# VME Equipment Behavior at the DFEL and Saskatoon Laboratories

U of S Subatomic Physics Internal Report SPIR-133

Daron Chabot

3rd November 2004

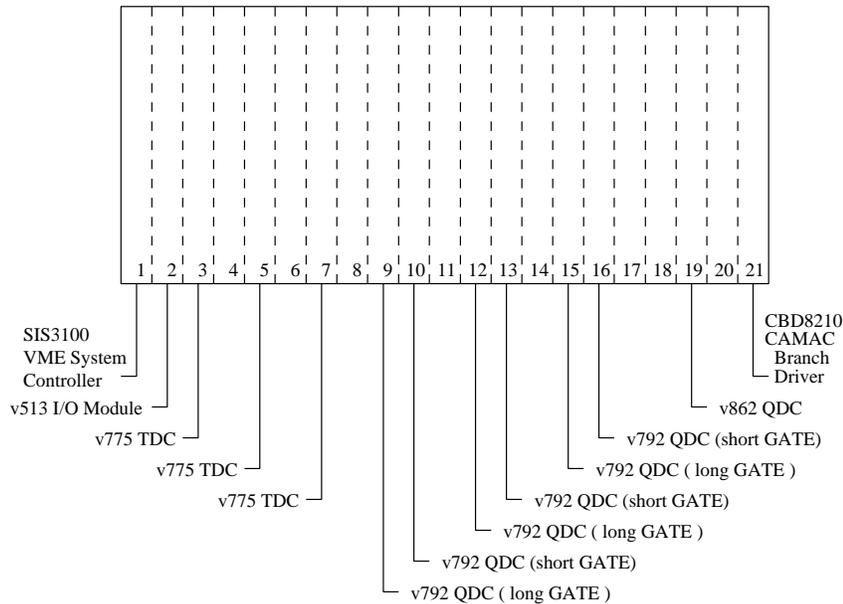
Figure 1: VME module position and type, as used throughout the testing phase of the PC-based DAQ while at DFELL.

The layout of the modules within the crate is illustrated in Figure 1. Note the vacancies in slots 4, 6, 8, 11, 14, 17, 18, and 20. These vacancies were present in an attempt to mitigate any thermal effects that may arise due to module heating/density.
